## Impact of Lake Michigan Water Levels on District Assets

Susan Coyle, P.E., CFM | Senior Project Manager

20 October 2022

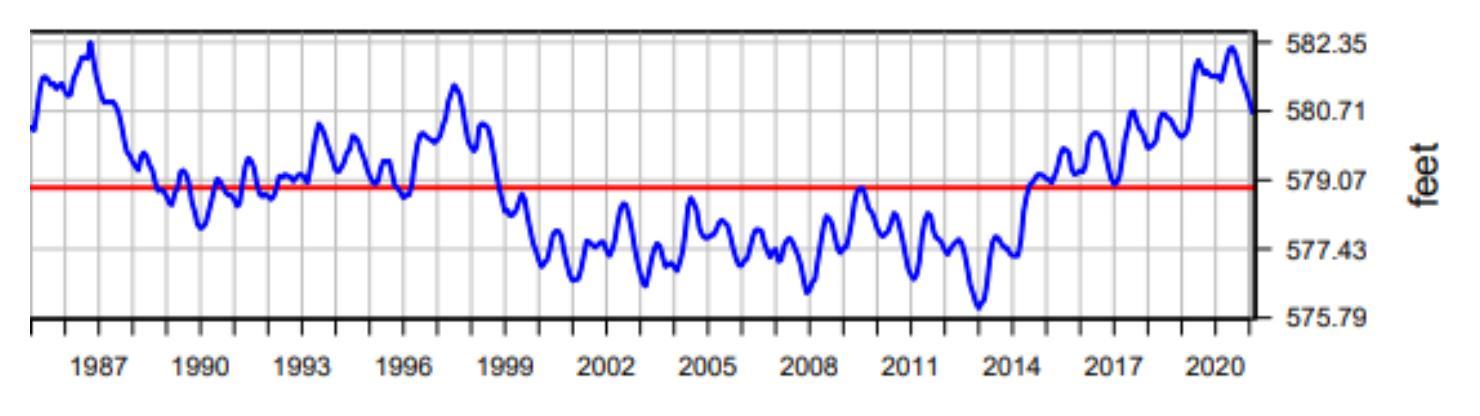
#### Lake Michigan-Huron

Monthly Mean Level

Long Term Average Annual

Source: https://lre-wm.usace.army.mil/ForecastData/GLBasinConditions/LTA-GLWL-Graph.pdf

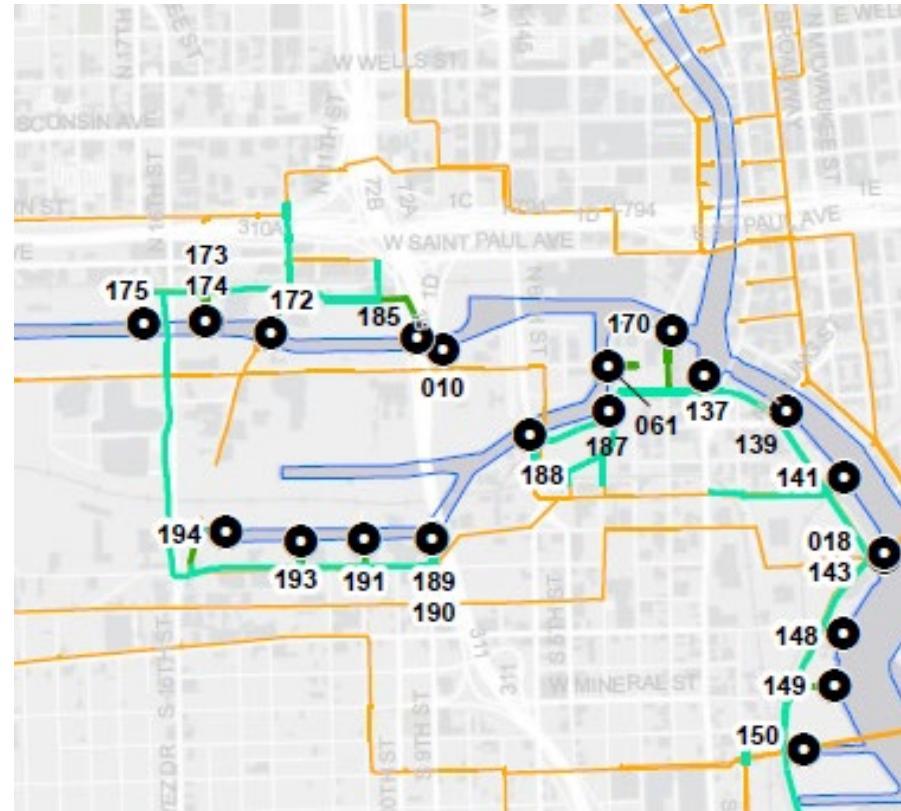
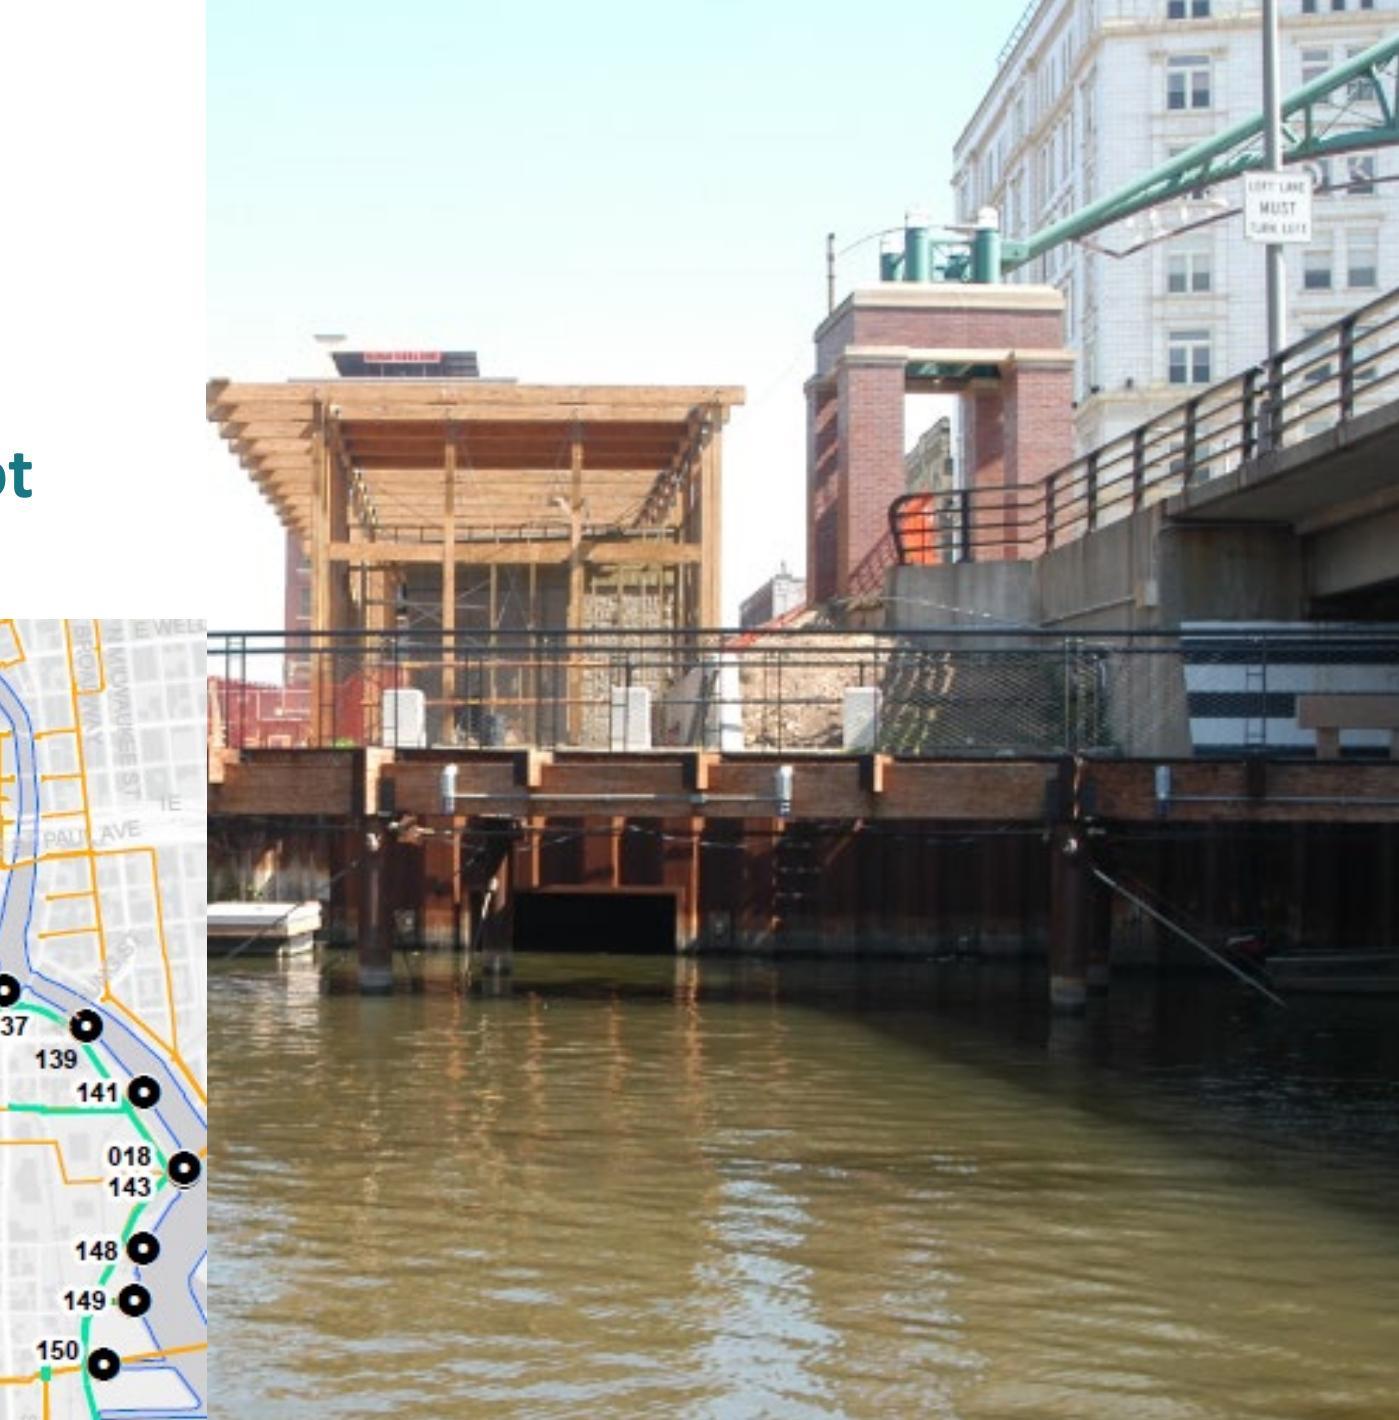
### Background Conveyance System

- Clear water coming in
- Combined sewer overflows cannot discharge

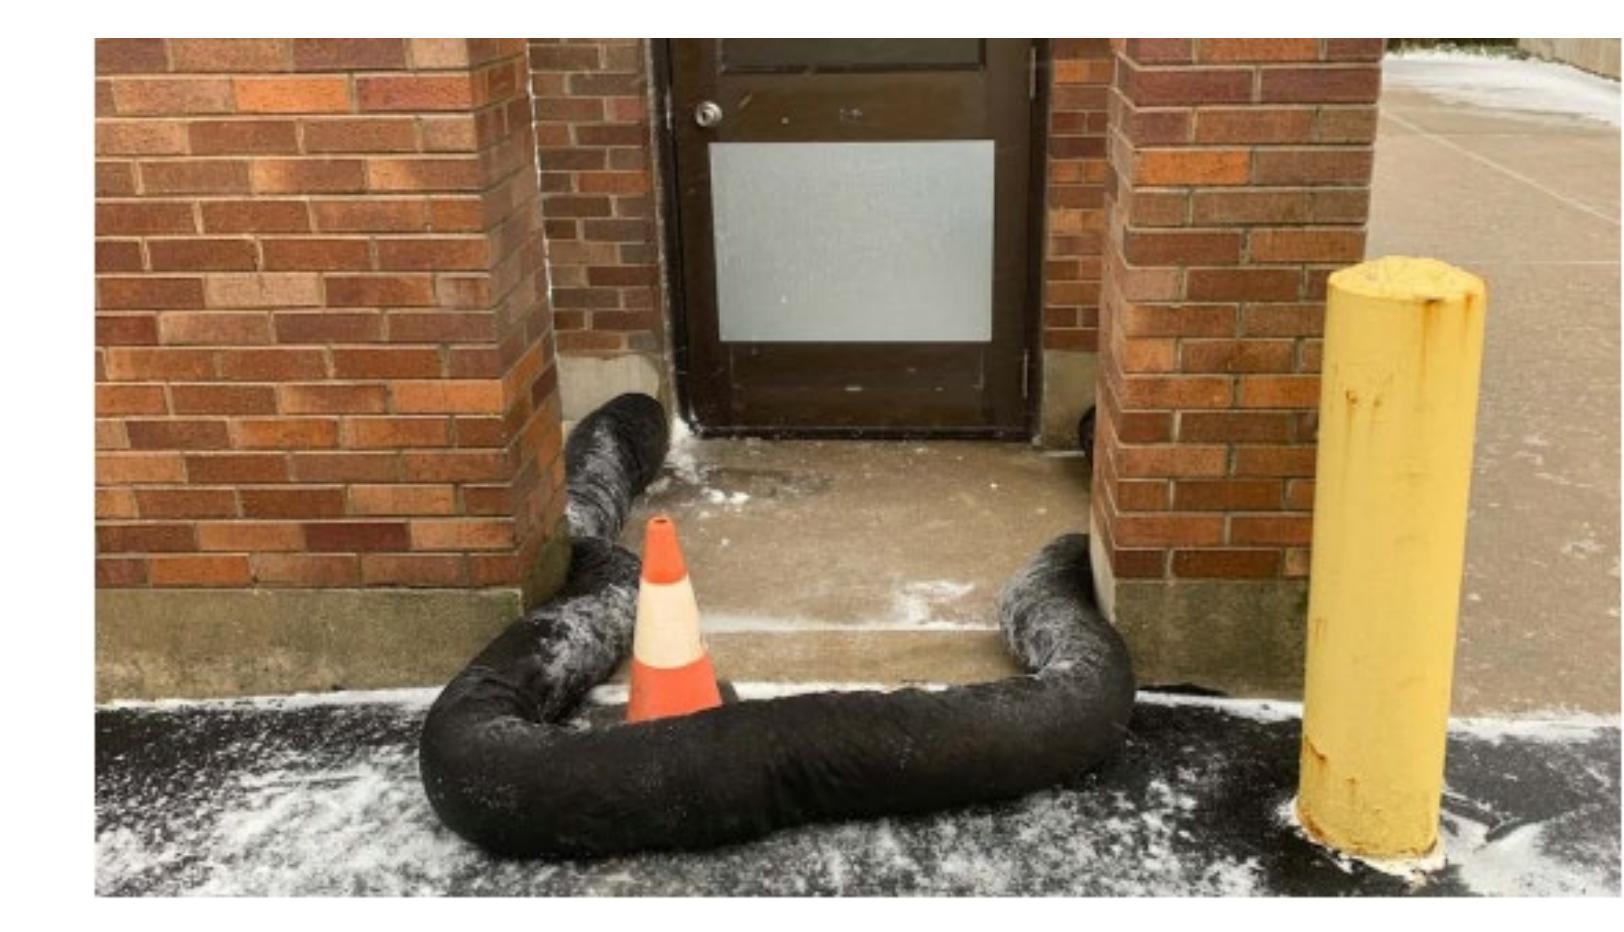
## Background Jones Island WRF

- High Lake Level
  - $\circ$  Overland flow
  - Infiltration
  - Effluent pumps
- Low Lake Level
  - Pile deterioration
  - Exposed intakes

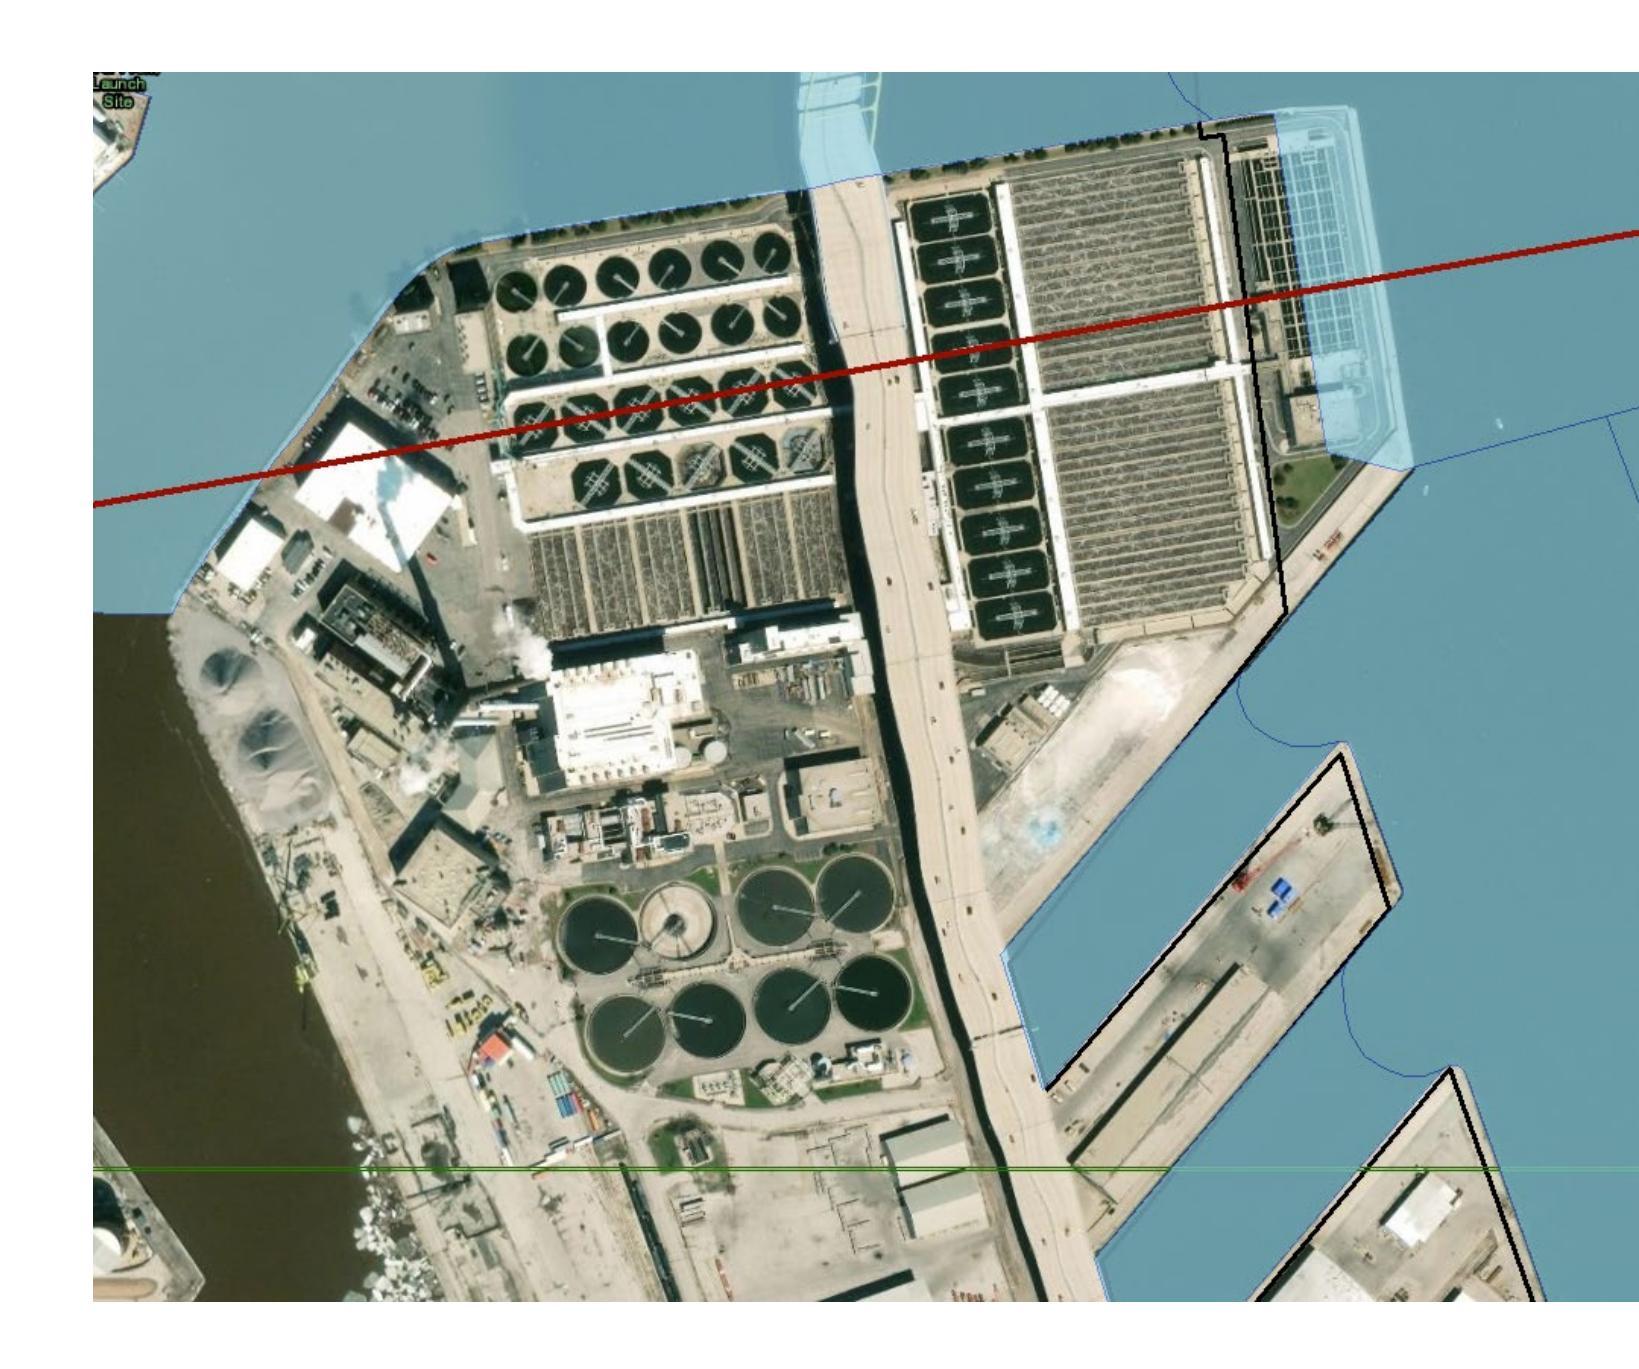
### Background Jones Island WRF

- New Coastal FEMA Maps
- Wave Runup
- Floodwall Results in Higher Flood Elevation

WAVE RUNUP SCENARIO (JIWRF)					
High Lake Level Coastal Flooding Storm Event at JIWRF Assuming Runup on Vertical					
Blukhead Shoreline Structure					
STILL WATER LEVEL (SWL), (FT, IGLD 85)	582.6				
WAVE HEIGHT (FT)	3.7				
WAVE RUNUP (FT)	8.4				
TOTAL WATER LEVEL ELEVATION, (FT, IGLD 85)	591.0				
EST. LIKELIHOOD	100-Year Return				
DEFEDENCES (NOTES	Base on draft FEMA coastal flood map				
REFERENCES/ NOTES	transect 14 for JIWRF.
